# BASTIÓN DE SAN DIEGO

INTRAMUROS ADMINISTRATION  
MINISTRY OF HUMAN SETTLEMENTS

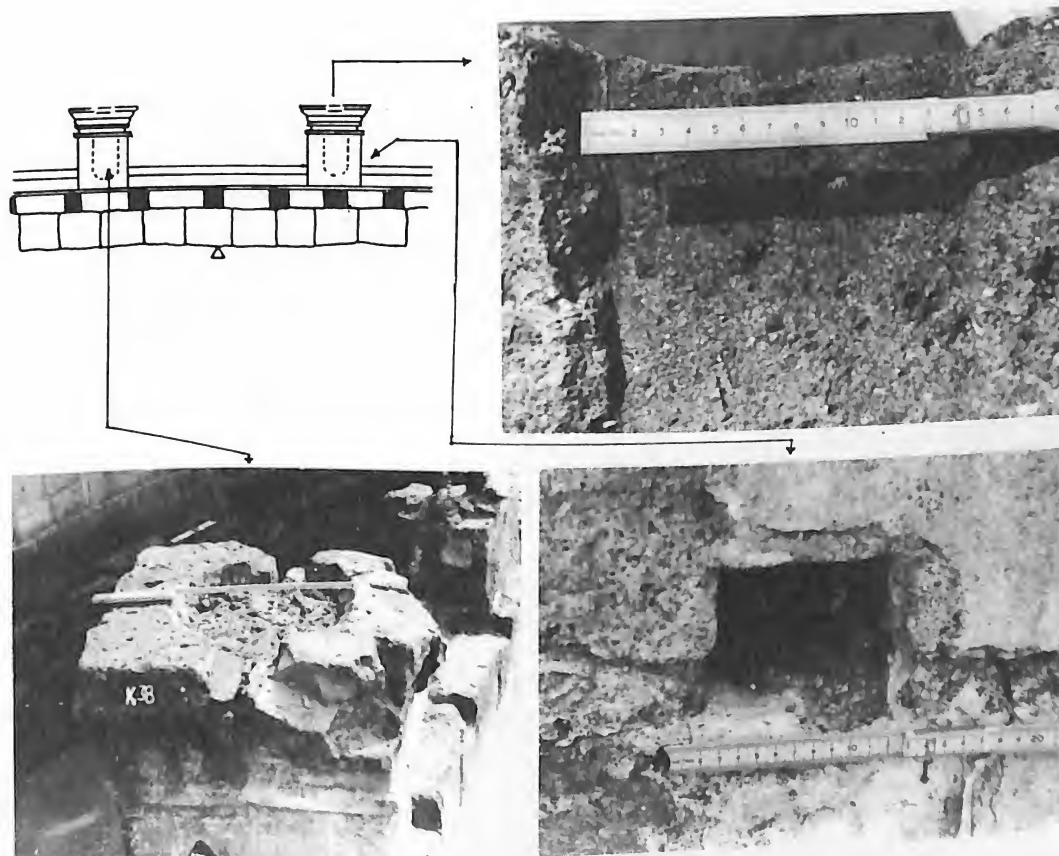
Figure 72. The front side of the top portion of the column slants downward with a depth of 4 centimeters.

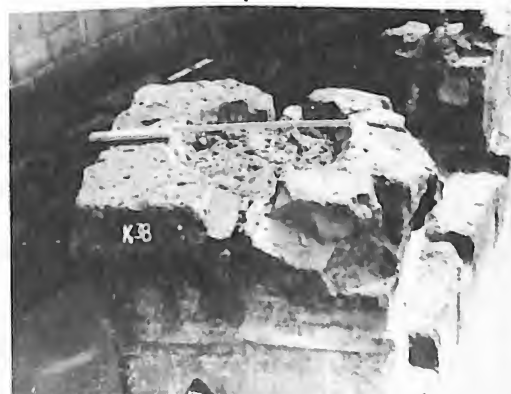
Figure 73. The height of this column is 1.08 meters and the entire body measures 60 centimeters. Top of the column has a circular hole measuring 30 centimeters in diameter extending downward for about 90 centimeters (see drawing).

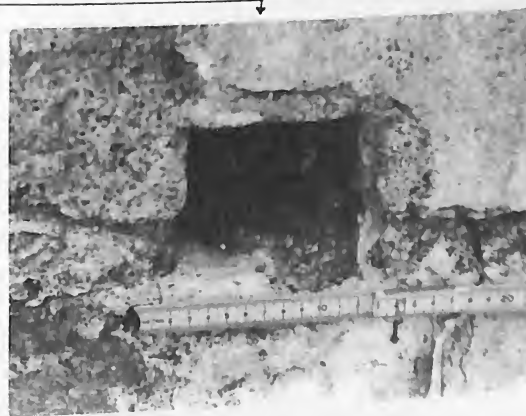
Figure 74. This square hole is one of two located on either side of the column. This feature accompanies all the columns excavated on top of the structure. Each hole measures about 10 centimeters.

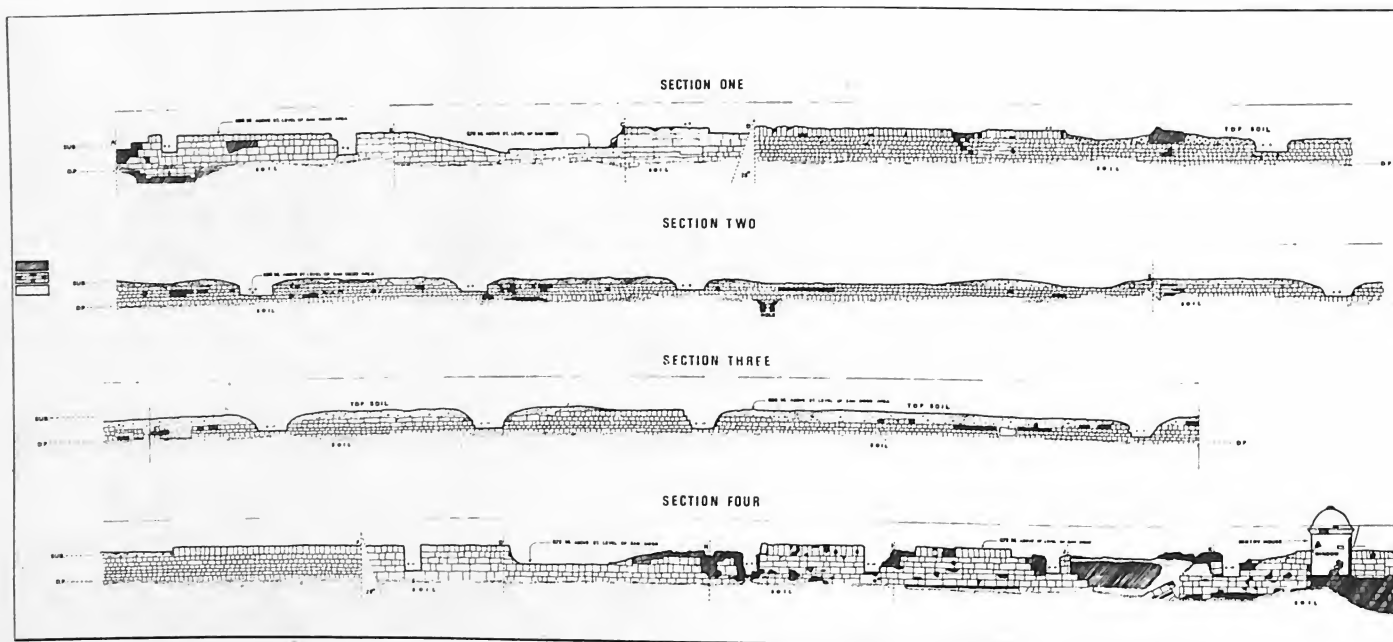
*The existing elevation of the Bastión de San Diego's outer wall.*
